## 270 WATER LEAKS AT WINDSHIELD OR BACKLIGHT ON UNITS WITH SERVICE REPLACEMENT GLASS

## 267 CHAFING OF THE MAIN BODY WIRING HARNESS IN THE AREA OF THE BRAKE PEDAL SUPPORT

## 269 ADDITIONAL LEG ROOM OR CLEARANCE BETWEEN STEERING WHEEL & DRIVER'S SEAT

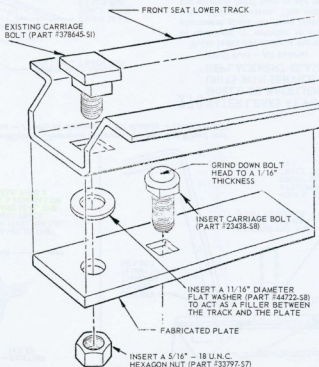
Under unusual conditions, additional leg room or additional clearance may be required between the steering wheel and driver's seat when the customer's physical size is in excess of the present design parameters. Due to the low percentage of complaints for additional clearance, no production corrections are being contemplated. To satisfy customer requests, the driver's seat can be moved 1 1/4 inch rearward to provide increased clearance and comfort. The following procedure should be used to move the seat rearward:

Fig. 8 - Insufficient Clearance Between the Steering Wheel and Driver's Seat - 1964 1/2-65 Mustang - All Models (Article 269)

4. Using a 5/16 in. - 18 x 1 1/4 carriage bolt (Part 23438-S8), grind off the top part of the bolt head until the thickness is 1/16 in. One bolt is required for each track. (See Fig. 8.)

5. Insert the carriage bolt (Part 23438-S8) and 11/16 in. diameter flat washer (Part 44722-S8) between the plate and the lower seat track as shown in Fig. 8. Attach one plate to each lower seat track using the existing bolt and a 5/16 - 18 hexagon nut (Part 33797-S7).
